8837-Ax – Product Fix:

Release date: 2008-12-02

Affected model: 8837-Ax – IGBT Chopper / Inverter

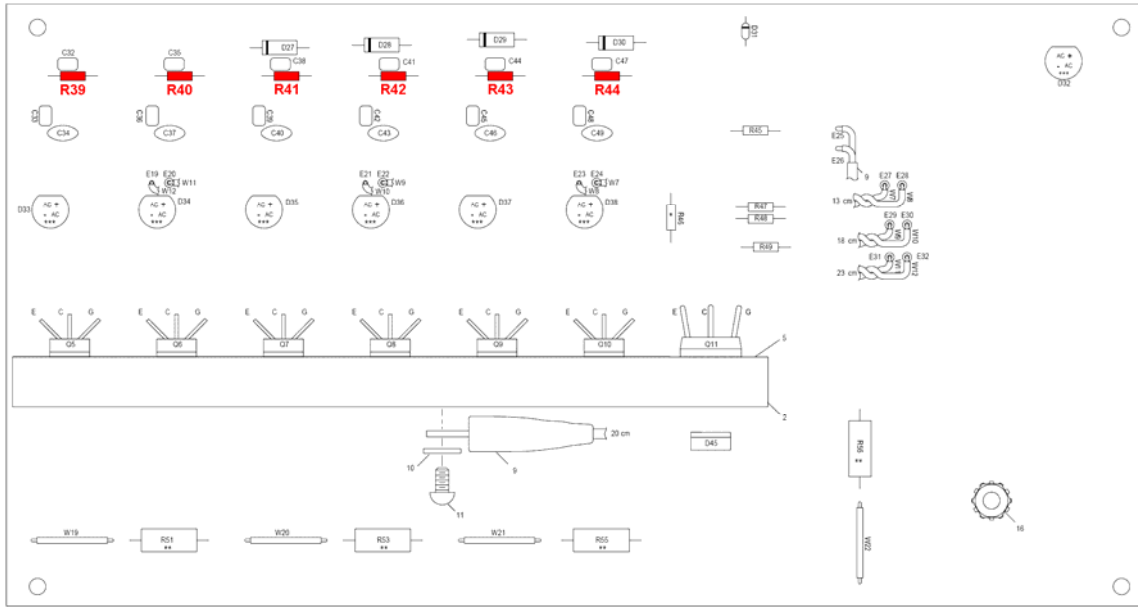
Symptoms: Random overcurrents and overheats may be detected by the module 8837-Ax when pulse signals, from the 9029-00 (Chopper/Inverter Control Unit) or the 9030-30 (Thyristor Firing Unit), are applied to the switching control inputs of this module.

Causes: The propagation delay time, at the opening of the IGBTs, is a little bit longer than the dead time (2 μ S) causing a momentary short circuit on the DC bus of the 8837-Ax.

Important: The resistors are located on the same side than the IGBTs as shown in the above figure. This means that they cannot be reached as long as the printed circuit board is not removed from the module's housing.

How to fix: To fix the problem, six resistors (R39, R40, R41, R42, R43 and R44) must be replaced on the printed circuit board. To know the new values of these resistors and their locations on the printed circuit board, refer to the table and figure below.

Identification	Current resistor value	New resistor value
R39	1 k Ω ¼ W 5%	510 Ω ¼ W 5%
R40		
R41		
R42		
R43		
R44
